Manhole Inspection Summary

Manhole # S27M1_017MH

Location Address: **2704 Berea Road** Cross Street: **Shellbanks Rd.**

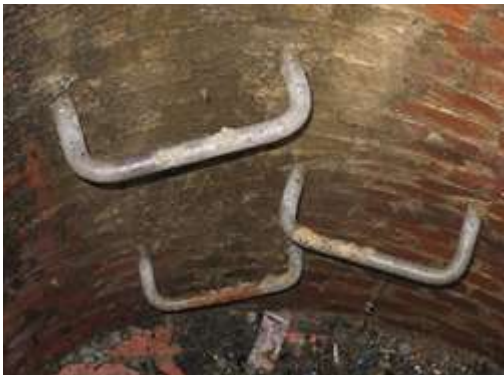
Steps Count: **3** Missing: **0** ☐ Corroded

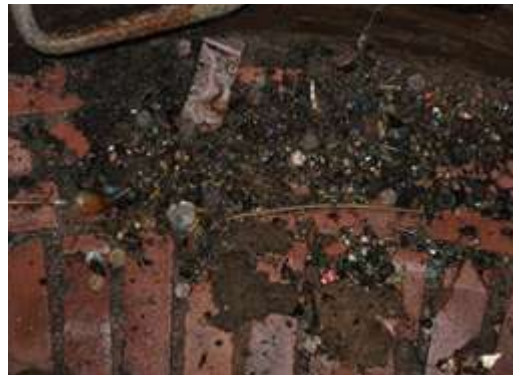
Defect 2

Bench ☒ Exists Material: **Brick** ☐ Parged
Condition: ☒ Sound ☐ Cracked ☐ Root Intrusion ☐ Deteriorated ☐ Leaks ☐ Debris

Bench

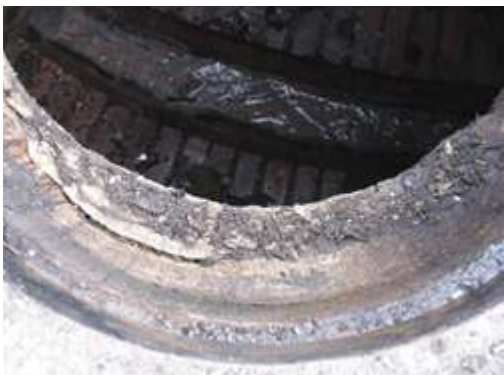
Defect 1

Frame Offset: **3** (in.) Condition: ☒ Sound ☐ Cracked ☐ Leaks

Frame offset

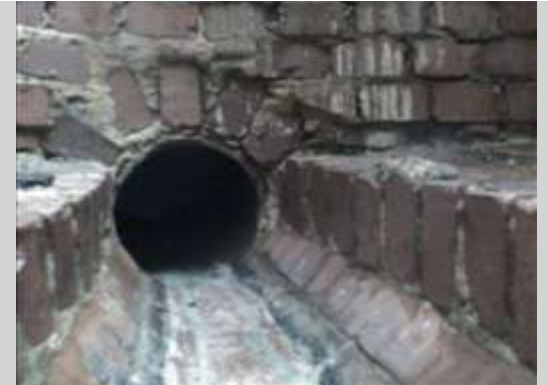
12 O'Clock Outflow

8 in. Circular Gravity Sewer
Pipe Out @ 12 O'Clock

Pipe Height: **10.8** (in.) Rod and Bar (Angled)
Pipe Material: **Clay** ☐ Pipe Lined
Invert Depth: **7.34** (ft.) Flow Characteristics: **Fast**
Deposits: ☒ None ☐ Mud ☐ Sludge ☐ Debris ☐ Grease
Silt Depth: (in.) Deposits Extent:
Infiltration: **None** Pipe Seal Cond: **Sound**

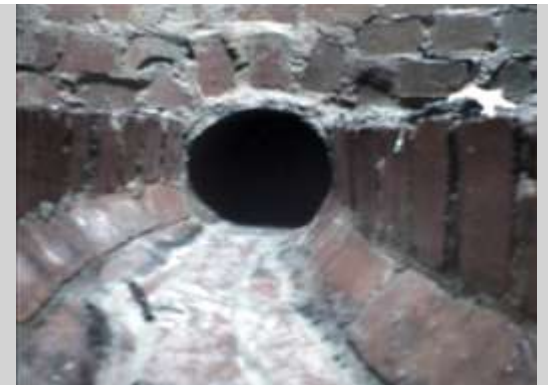
6 O'Clock Inflow

8 in. Circular Gravity Sewer
Pipe In @ 6 O'Clock

Pipe Height: **9.6** (in.) Rod and Bar (Angled)
Pipe Material: **Clay** ☐ Pipe Lined
Invert Depth: **7.27** (ft.) Flow Characteristics: **Fast**
Deposits: ☒ None ☐ Mud ☐ Sludge ☐ Debris ☐ Grease
Silt Depth: (in.) Deposits Extent:
Infiltration: **None** Pipe Seal Cond: **Sound**
